Kei Home Inspections, LLC

CONFIDENTIAL INSPECTION REPORT

1234 W. Living Right Drive, Anywhere, AZ 85000

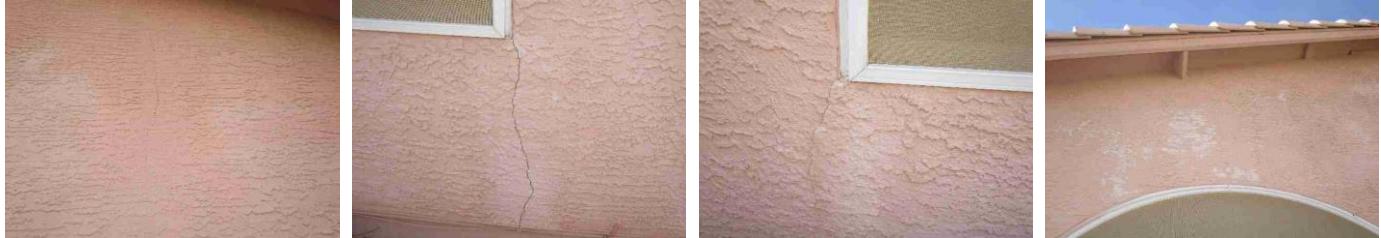
There are typical cracks/ imperfections in the stucco. All cracks result from movement, and are structural in that respect, but the vast majority of them have only a cosmetic significance.

Check and seal as necessary.

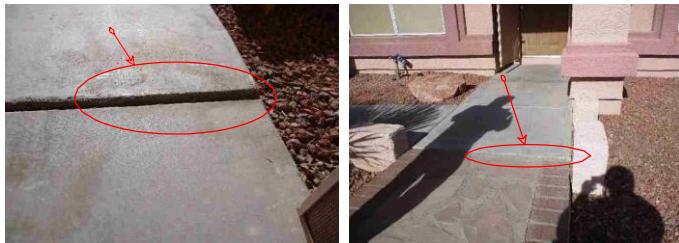
The deco-drain is damaged and you may wish to have it serviced. (Could be a trip hazard with shoes that have pointed heels)

There are offsets in the front walkway that could prove to be a trip-hazard.

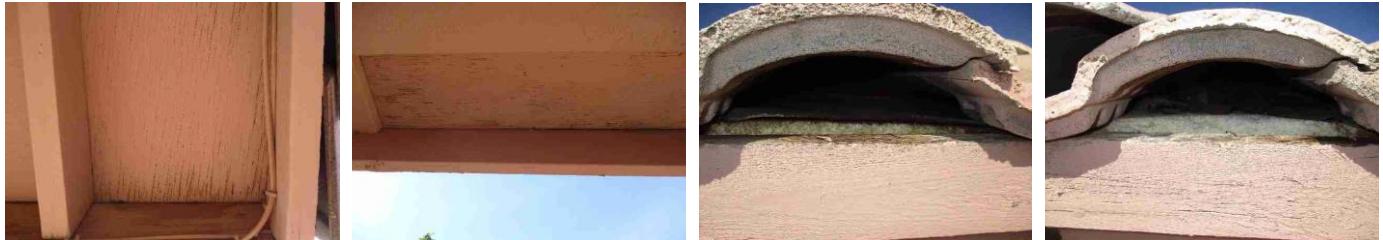
- Moisture stains noted on eave sheathing located at different areas of the home. The source of moisture should be determined and corrected.
- The underlayment has begun to or is curling at the leading edge of the roof and or at the ridge line and should be further evaluated by a roofing contractor and serviced as necessary.
- Moisture stains noted at the garage that would be considered roof related.
- The roof underlayment may be near the end of its design-life and will certainly need to be monitored more closely.

A review of the roof by a roofing contractor within the inspection period is recommended to determine the estimated life span of the underlayment.

This service should be scheduled as soon as possible with a roofing contractor because additional conditions in need of service could be revealed by a specialist, and our service does not include any guarantee against leaks.

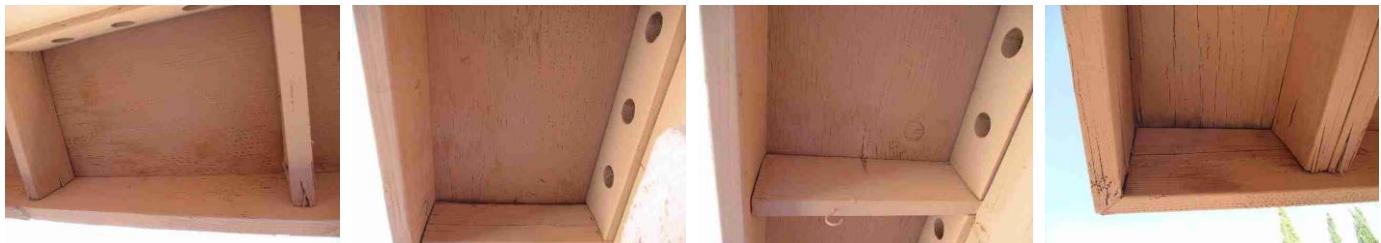
Sections of the eaves have moisture staining.

The patio roof appears to be a new roof and the stains are probably from the previous roof.

We recommend consulting with the homeowner for further information.

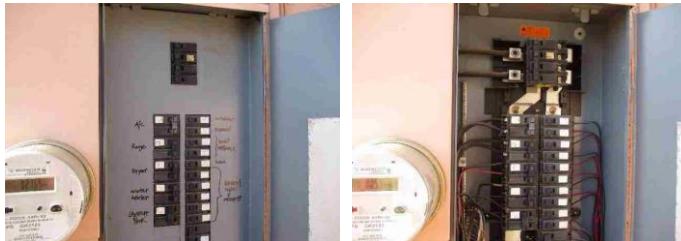
The residence is served by a 200-amp single throw, 110/220-volt panel, located at the front side of the residence.

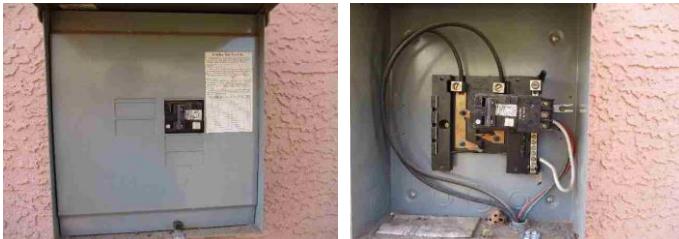
The sub panel is located
Exterior rear East side of house;
